CONNECTICUT RIVER BASIN
MANCHESTER, CONNECTICUT

HOWARD RESERVOIR DAM

CT 00015

PHASE I INSPECTION REPORT
NATIONAL DAM INSPECTION PROGRAM

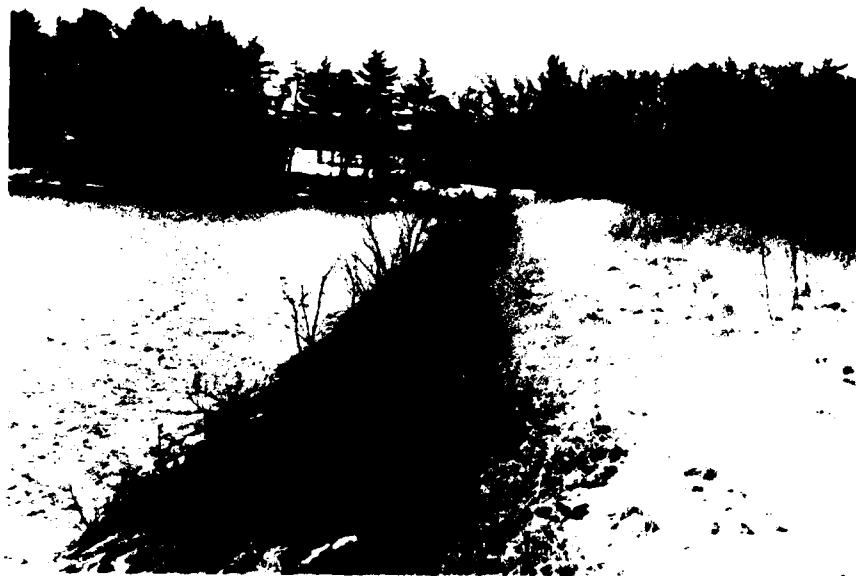
Overview of dam from right abutment
